AMSOIL Pi: A Study in Performance

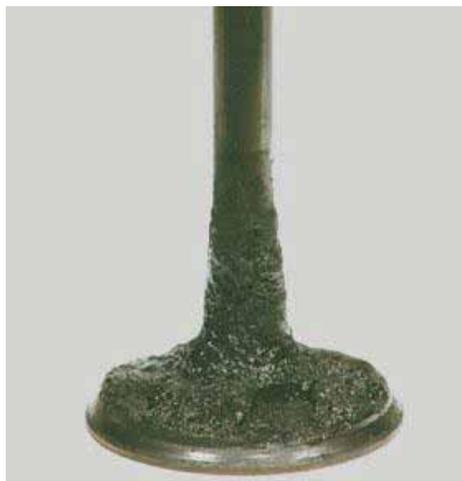
Picture D shows a dirty, deposit-covered valve, while **Picture E** shows the same valve cleaned with P.i. The dirty valve leaves an undulating surface that disrupts air flow into the cylinder and absorbs a portion of the fuel sprayed by the injector, while the clean valve contributes to improved fuel economy, lower emissions, better drivability and maximum power.

Picture D - Intake valve before P.i. treatment

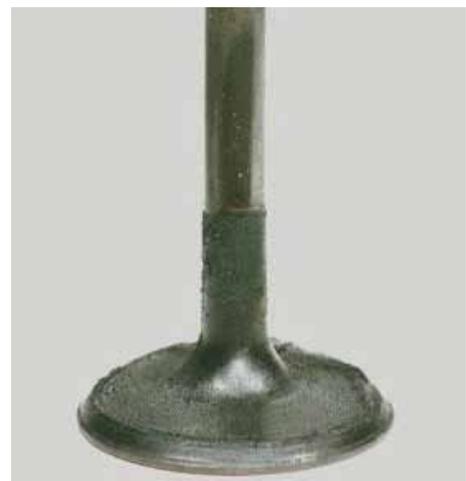
Picture E - Intake valve after P.i. treatment

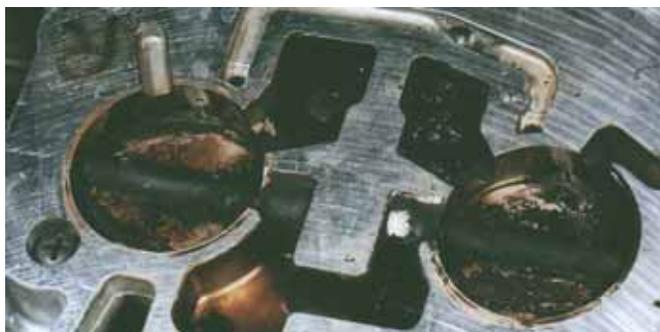
Picture J shows dirty, deposit-covered carburetor plates, while **Picture K** shows the same carburetor plates cleaned with P.i.

Picture J - Carburetor plates before P.i. treatment
